Tree damage caused by mobile phone base stations

An observation guide

By Helmut Breunig

March 2017

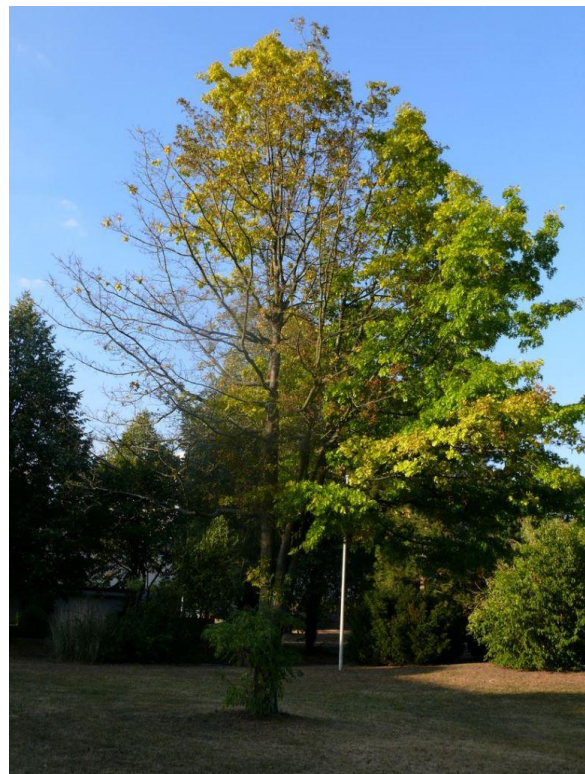
Red oak tree, August 2013

Red oak tree, August 2015

The damage area spreads across the crown over the course of the coming years. At the individual branches, the sight is similar to drought damage. The spatial and temporal development of the damage area as a whole, however, is not typical for drought damage that occurs as a result of a lack of water at the roots.

The loss and discoloration of the leaves is most prominent where the tree faces the RF transmitter. The spread of the damage area follows a pattern independent of the branch architecture of the tree.

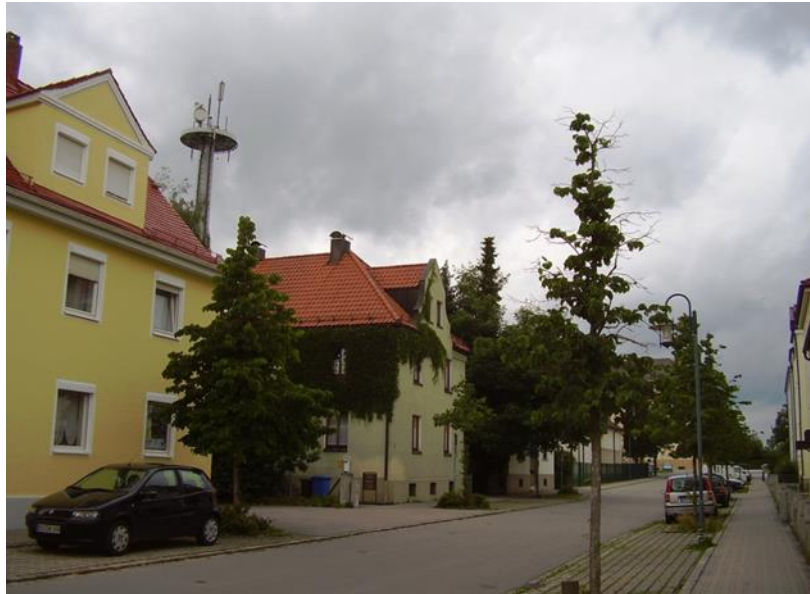
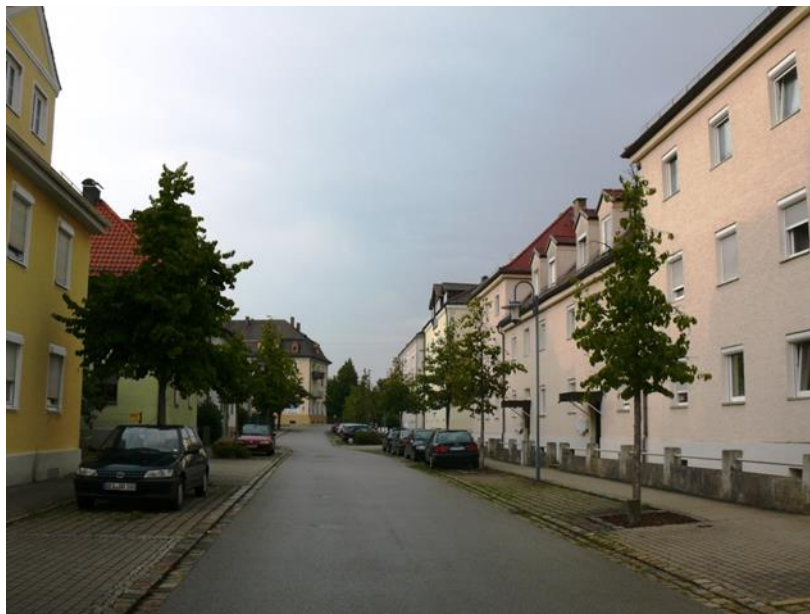
*Tree-lined road
Turkish hazel trees,
June 2008*

*Tree-lined road
Turkish hazel trees,
August 2013*

The Turkish hazel trees on the left are mostly in the radio shadow of the buildings. The line of trees on the right side of the road are more exposed; both directly and indirectly (reflection from buildings). The bare shoots and dead twig tips of the transparent crowns of the trees on the right side of the road reveal the level of stress caused by the RF radiation.

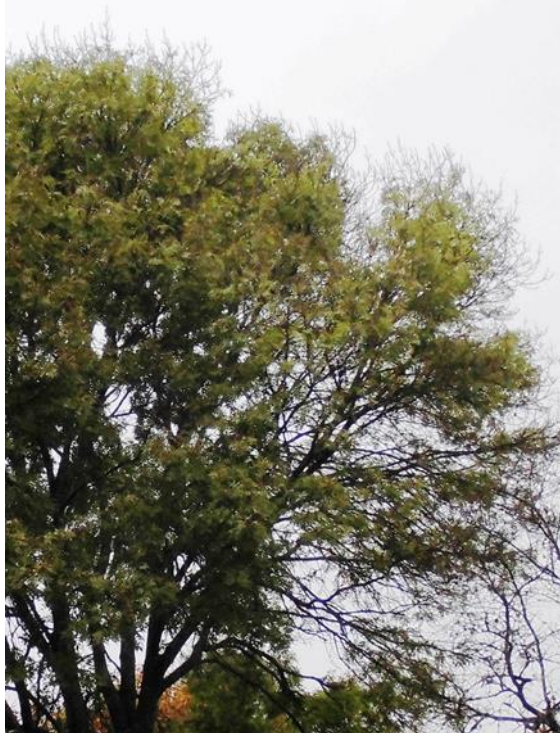
Tree site at a slope

*<- Exposure from the right
from RF transmitter at
the same height,
distance 500 m
(ca. 1600 ft)*

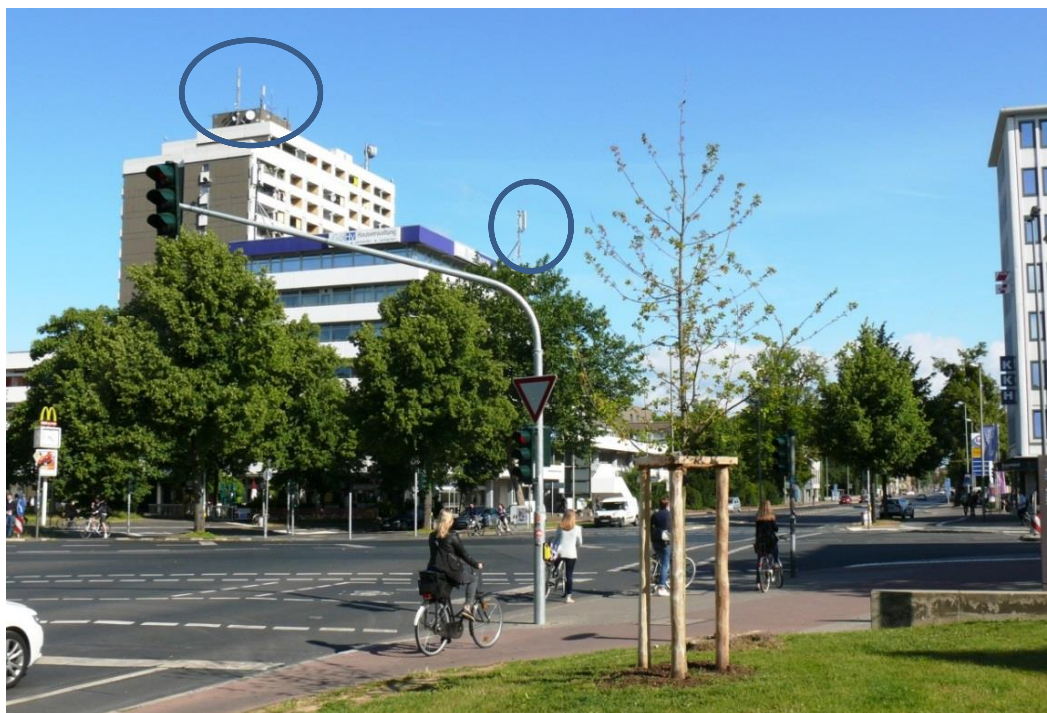
*Typical city view with trees in the vicinity of mobile phone sites
July 2015*

The linden trees to the left in the blind spot near the antennas (marked) don't seem to be adversely affected. Other trees in the background along the road and the newly planted tree in front of the building all are in the line of sight of the RF transmitters on the rooftop. Here we can recognize damage to the shape of the top of those trees and to the density of their foliage.

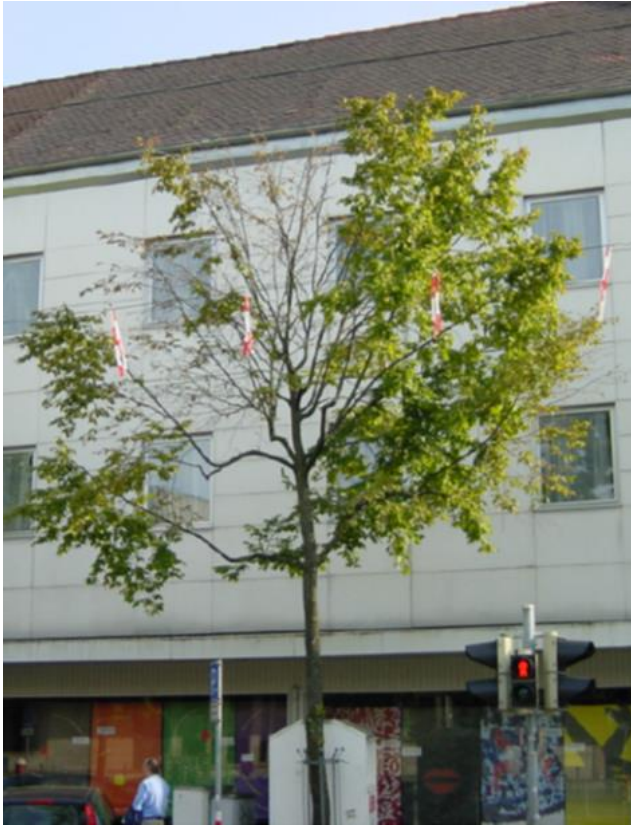
Maple tree, September 2006

SCHORPP points out that the inhomogeneous emissions of the antennas as well as the reflection, diffraction, and scattering effects at buildings may lead to well-defined, small-area differences in power density levels.

These types of crown dieback are new and only occur around built environments.
