Tree damage caused by mobile phone base stations

An observation guide

By Helmut Breunig

March 2017

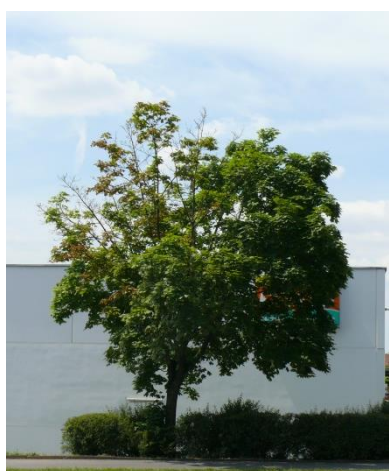
June 2015

The annual increase in leaf loss most likely can be traced back to an impairment of the buds in the year before. The resulting decreased level of shoots for leaves and branches causes the closed crown to open at those points, whereby one quarter of the crown outline starts breaking up.

With increasing leaf dieback, the attenuation effect of the foliage decreases, starting at the edge of the crown.

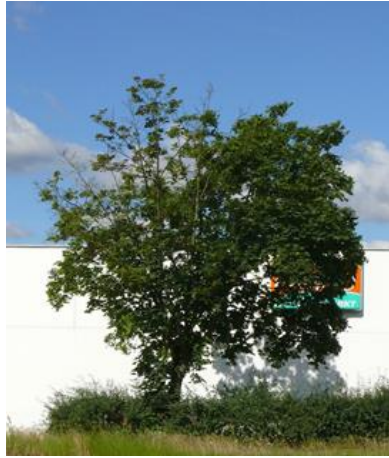
July 2016

Inside the crown, there are naturally less leaves because of shadow

effects. This is why – after the more dense foliage at the crown edge has receded – it is easier for the RF radiation to cross over to the other side of the crown. As a result of the increasing RF exposure level, the crown then also starts to lose leaves in this opposite area and thus the tree's inherent attenuation also decreases. In this way, the damage area spreads from the inside to the outside of the side of the crown edge facing away from the RF transmitter.

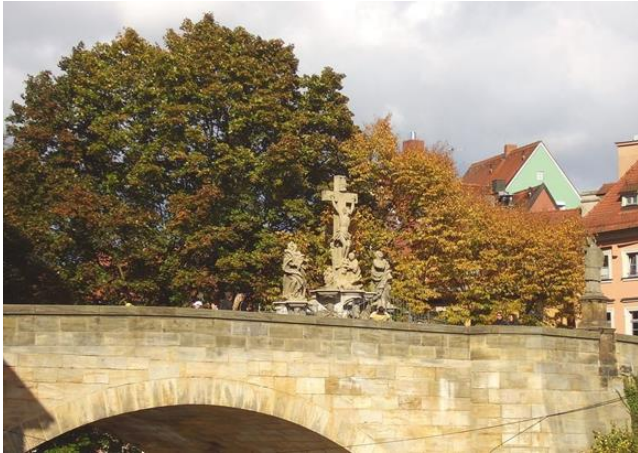
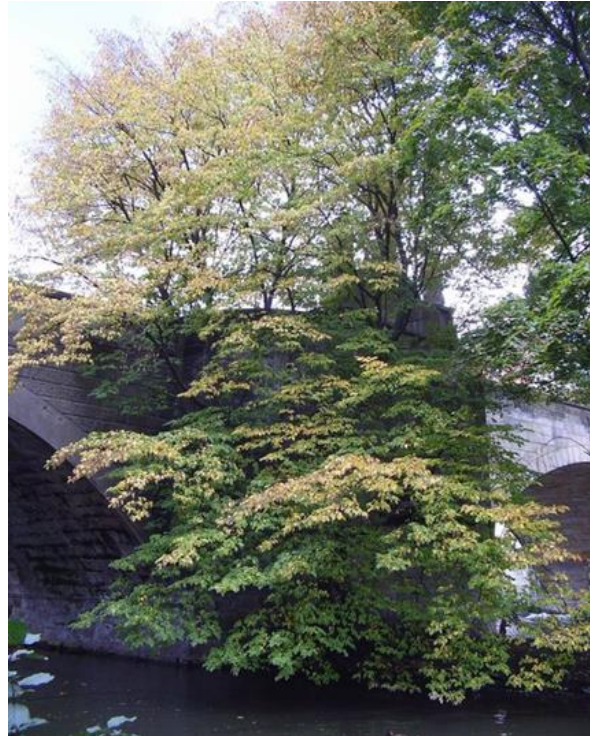
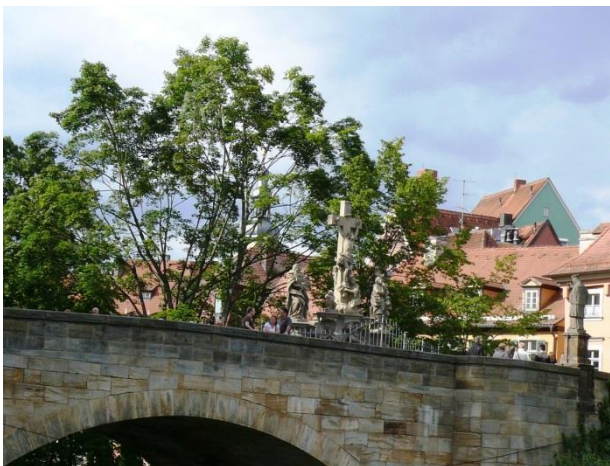
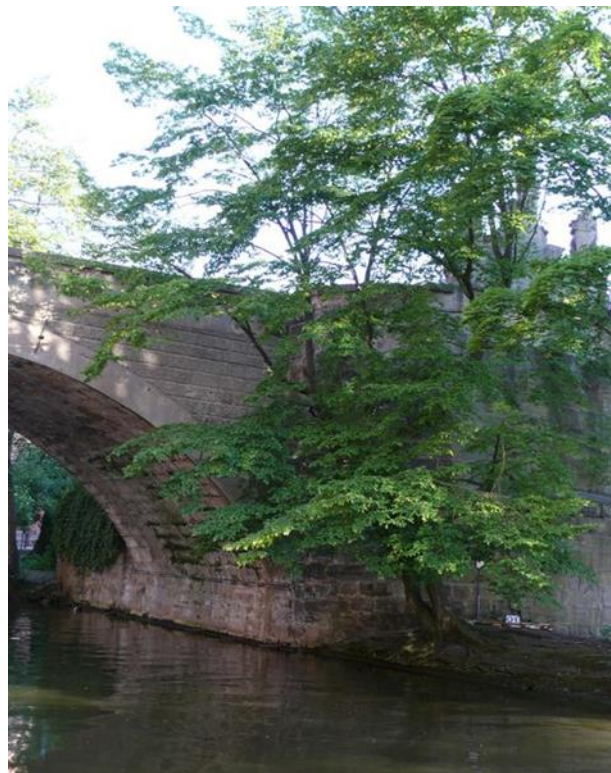
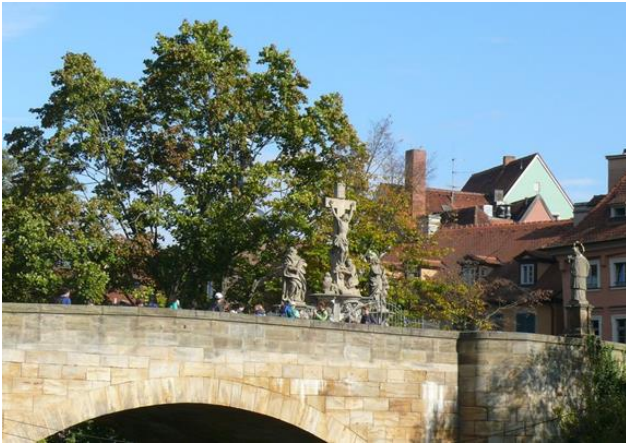
The upper part of the crown that reaches above the bridge structure is exposed by an RF transmitter. Despite excellent light conditions and a good water supply, leaf loss occurs at this location. The lower part of the foliage is dense and healthy because it is protected by the bridge structure.

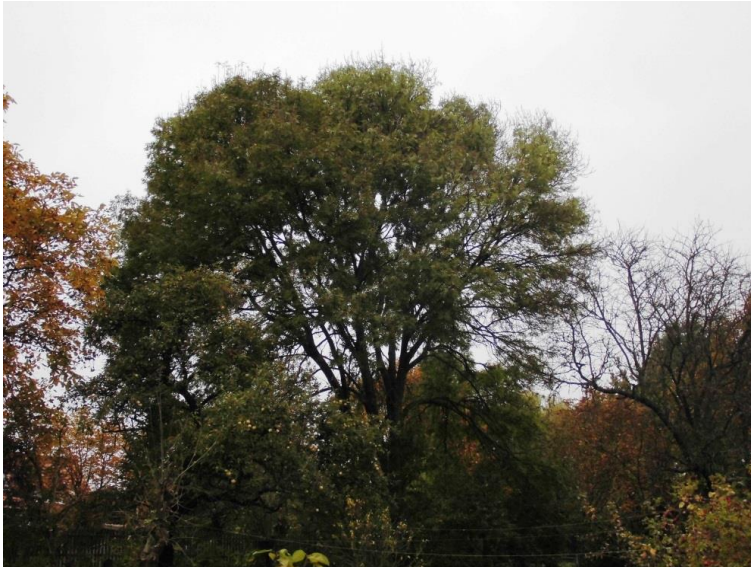
At the edge facing the RF transmitter, the leaf loss and the coloration differences within the crown show the damage gradient from the starting point of damage to the damage area.

Ash trees naturally lose their leaves in fall without major discoloration. If the leaves of one tree start falling in different areas of the crown at different times, this can be the result of a one-sided RF exposure. This characteristic requires observing the tree over several years. Thus it would be possible to distinguish the damage from the acute effects of frost, which can be caused by cold air that blows in from the side.

Ash tree, October 2016
